# Important **Safety** Information

**Do you have this type of  
gas piping in your home  
or business?**

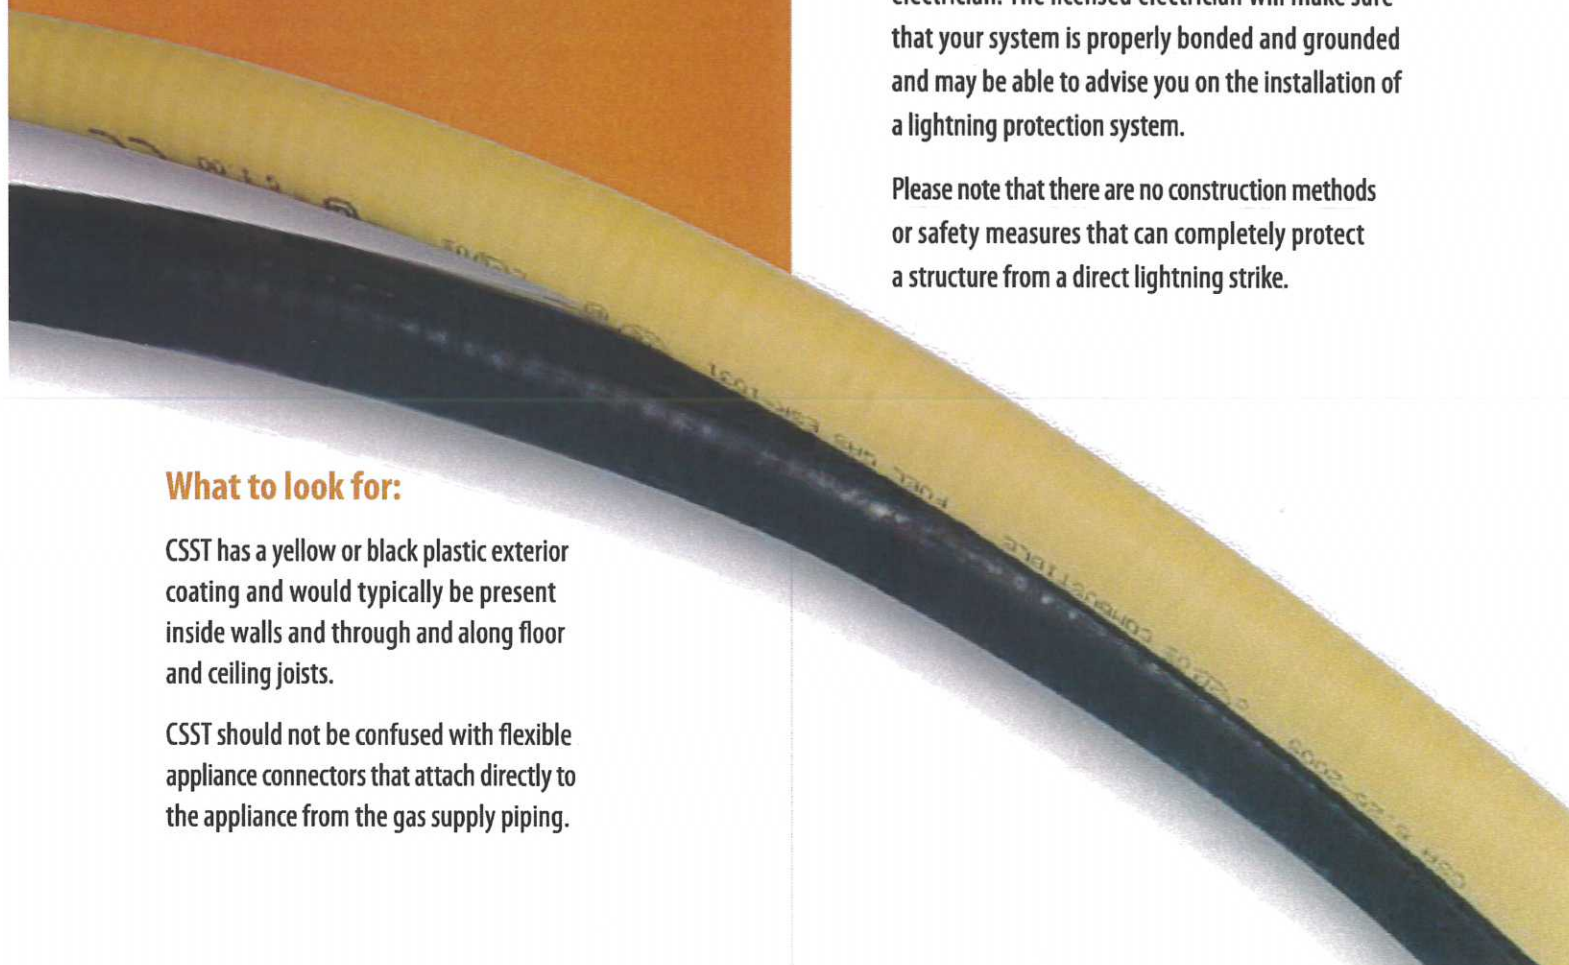
CSST has a yellow or black plastic exterior coating and would typically be present inside walls and through and along floor and ceiling joists.

CSST should not be confused with flexible appliance connectors that attach directly to the appliance from the gas supply piping.
